Confidential Inspection Report

LOCATED AT: 2468 Somewhere Street
San Diego, California 92111

INSPECTED ON: Sunday, April 12, 2026

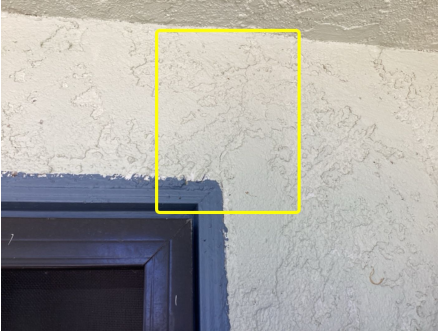
Example 1: Front Door

23: CONDITION: Settlement cracks on the siding. These cracks are caused by a slight movement of the structure right after the home was built. Recommend contacting a stucco contractor for further evaluation and / or a stucco contractor for repairs.

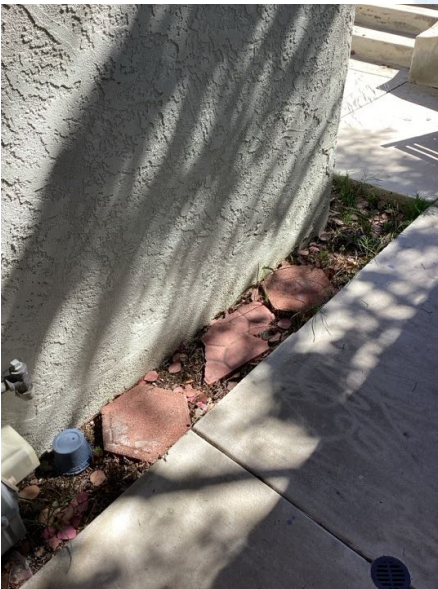
Example 1: Rear

24: CONDITION: Weep screed at the lower portion of the stucco wall is installed to allow water/moisture absorbed by the stucco to drain/weep out and prevent damage to the framing or prevent moisture from entering the interior. The weep screed is less than the present standard distance of 2" to concrete. Recommend correcting around the house by a stucco contractor.

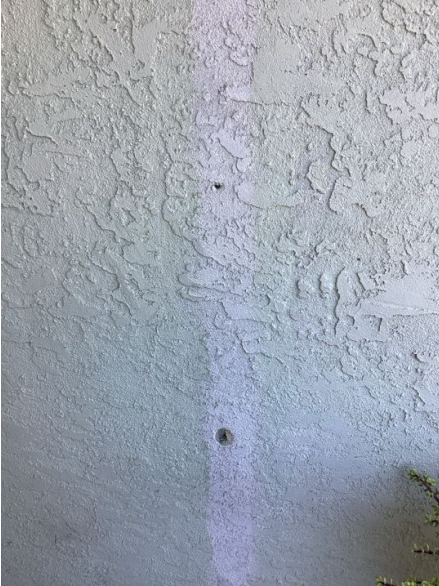
Example 1: Front Door

25: CONDITION: Hole in siding. Recommend repair of damaged sections to keep moisture and insects from harming structure.

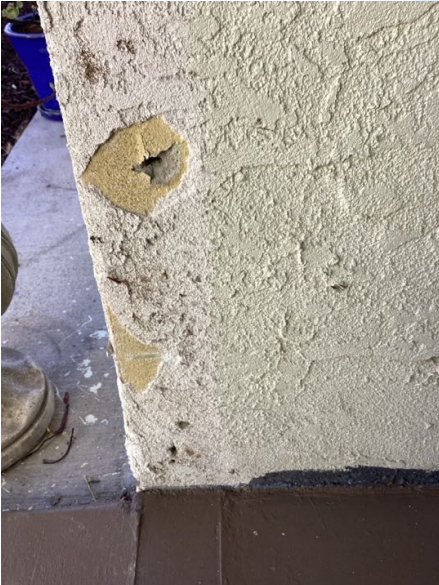
Example 1: Front Door

26: CONDITION: Stucco siding damaged. Recommend repair or replacement of damaged sections to keep moisture and insects from harming structure, by a stucco contractor.

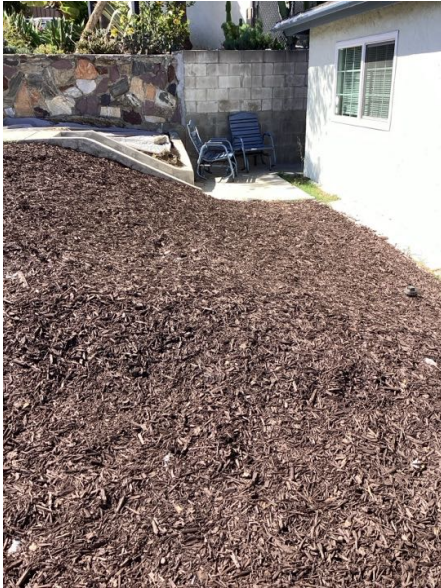
27: Exterior grading is improperly sloped towards the foundation. Water can intrude into the interior. Recommend creating the proper slope away from the foundation and/or installing drains to allow for proper drainage, by a landscape contractor.

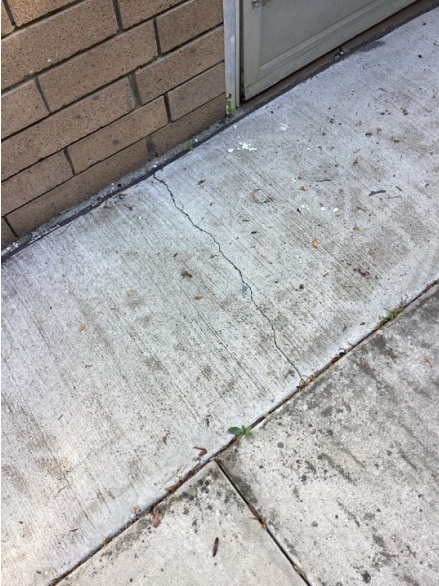
Example 1: Left Side

39: CONDITION: Minor settlement or "hairline" cracks in the patio. This cracking of the cement is a common occurrence, usually occurs during the drying process.

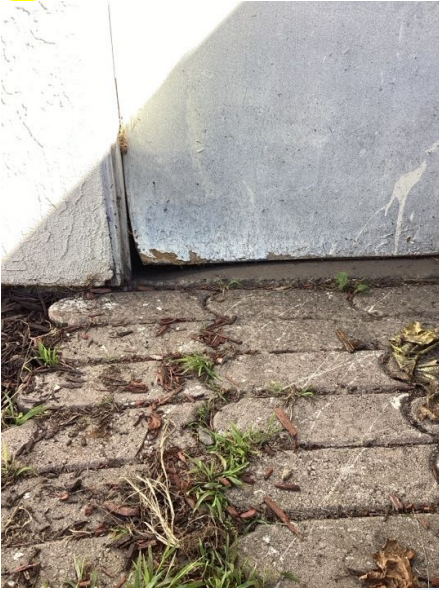
Rear Garage Entry

42: Wood damage noted. Recommend contacting a pest control specialist for further evaluation of all doors.

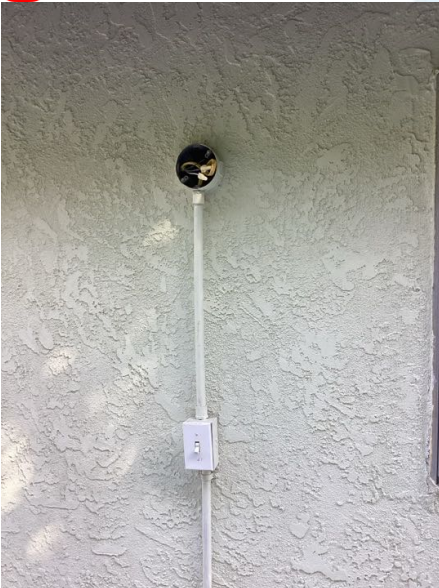
Example 1: Left Side

43: Light fixture is missing. This is a safety hazard. Recommend replacement by an electrical contractor.

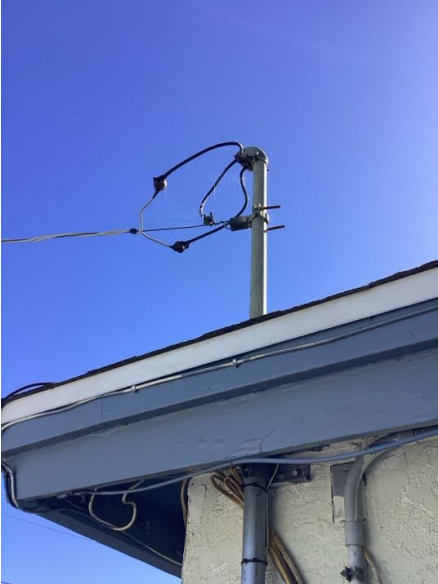
Main Electrical Service

46: PANEL: Main panel is manufactured by Cutler Hammer. The main disconnect is at the main electric panel. This switch will turn off all power to the home. This switch has a maximum amp capacity of approximately 125 amps/ 240 volts.

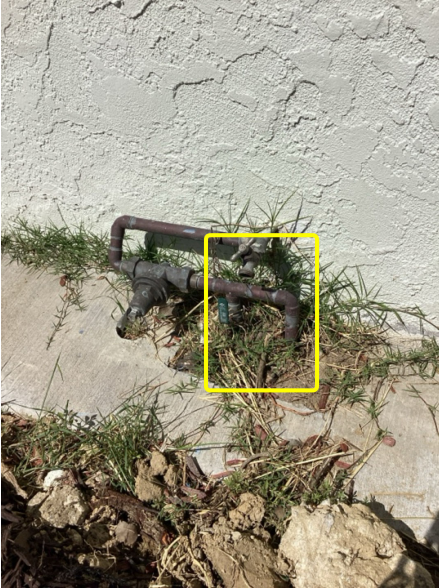
Main Water Shut Off: Left Side

57: HOME SHUT-OFF: House water shut-off valve is located on the side of the house.

58: Water shut-off valve is present and presumed to be functional. Valve is a recommended "Ball" valve.

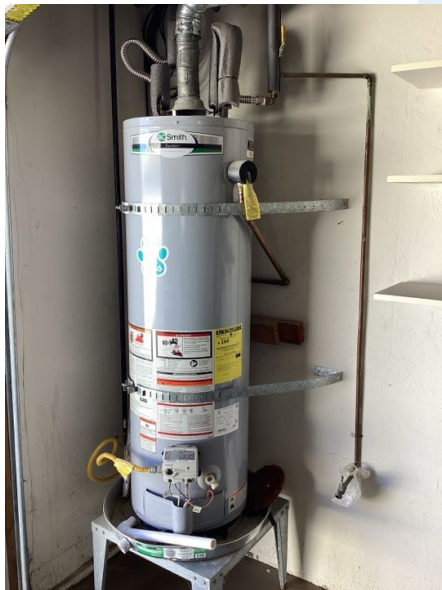
69: MANUFACTURER: 40 gallon, gas, water heater, manufactured by AO Smith.

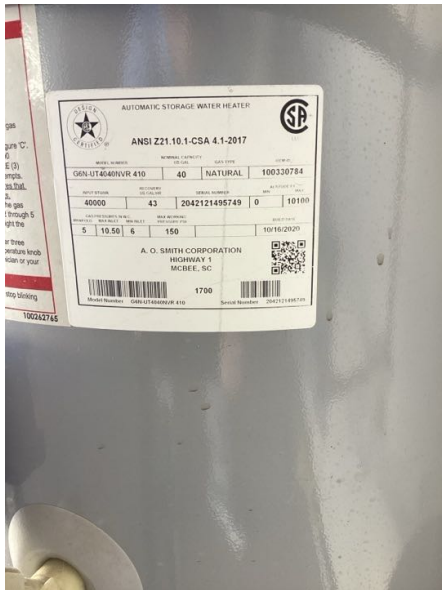
70: Water heater is approximately 6 years old. The average life of a water heater is 12 years in Southern California.

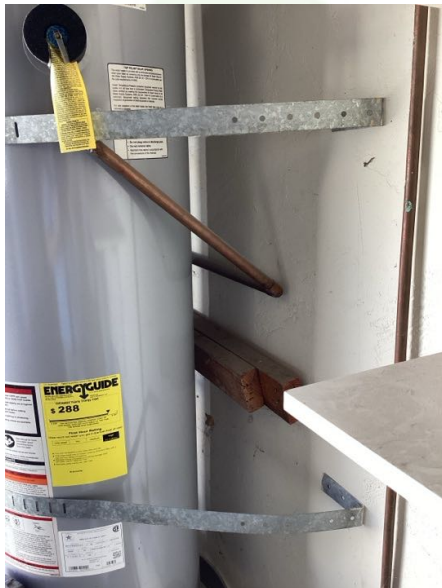
84: Although the water heater is strapped, it is not braced. This is a safety hazard. Recommend correction by a plumbing contractor.

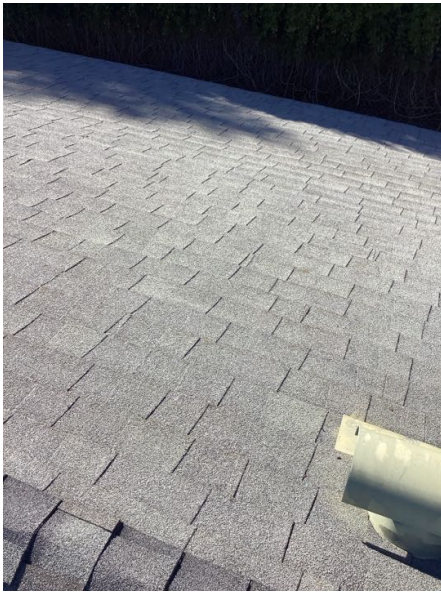
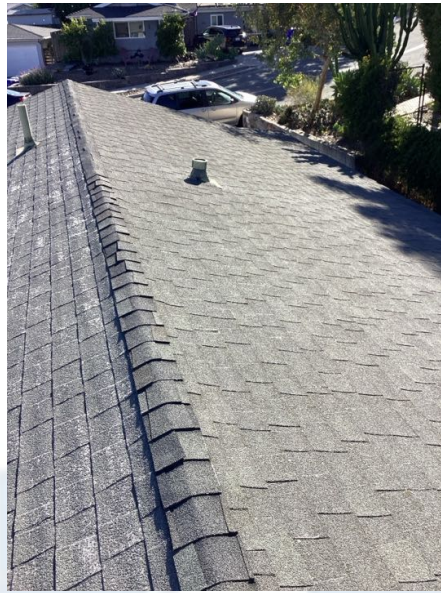
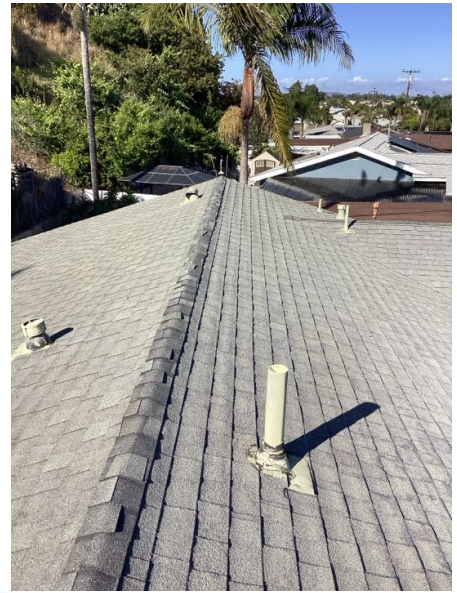
90: CONDITION: Roof is near the end of its useful life. This is a moisture intrusion hazard. Recommend replacement by a roofing contractor.

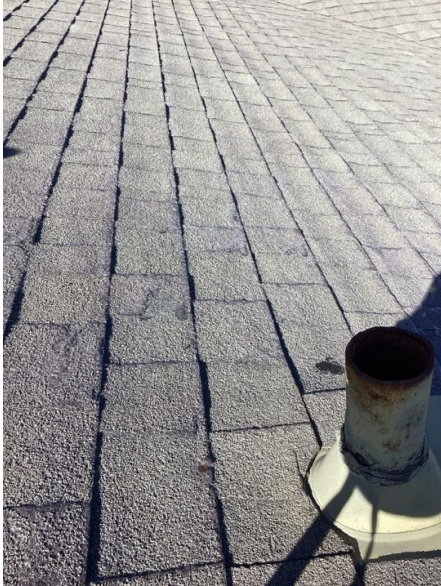
93: CONDITION: Shingles losing their granules. This typically indicates either an old roof or inferior covering. Granules protect the roofing material from UV damage. Recommend correction by a roofing contractor.

94: CONDITION: Roofing deteriorating. This is a moisture intrusion hazard. Recommend repair / replacement of the roof by a roofing contractor.

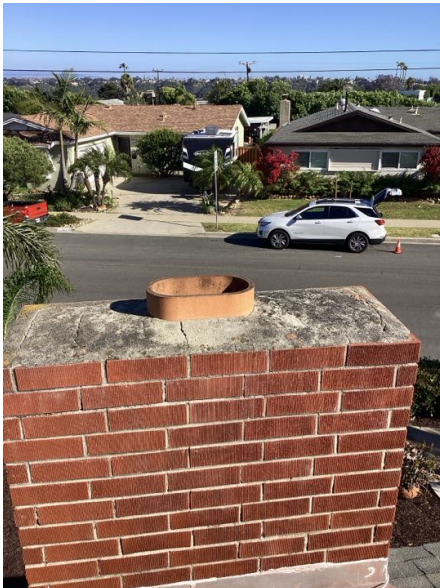
Missing Spark Arrestor

107: SPARK ARRESTOR: Spark arrestor screen is missing; this screen prevents sparks from escaping and stops animals/birds from entering chimney. This is a fire hazard. Recommend replacement by a chimney/fireplace specialist.

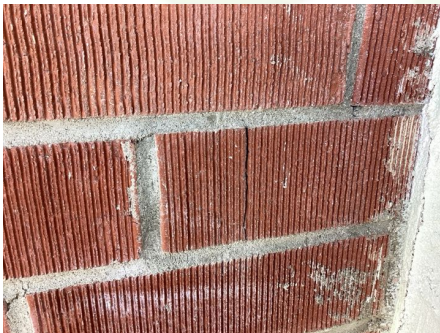
Example 1

108: EXTERIOR SURFACE: Minor crack on the exterior observed. Recommend further evaluation and/or repairs or replacement by a chimney / fireplace specialist.

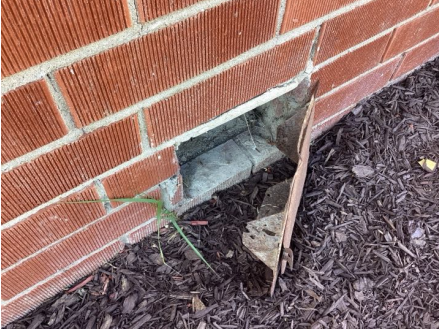
109: EXTERIOR SURFACE: Ash clean-out door is damaged. Recommend repair or replacement by a chimney/fireplace specialist.

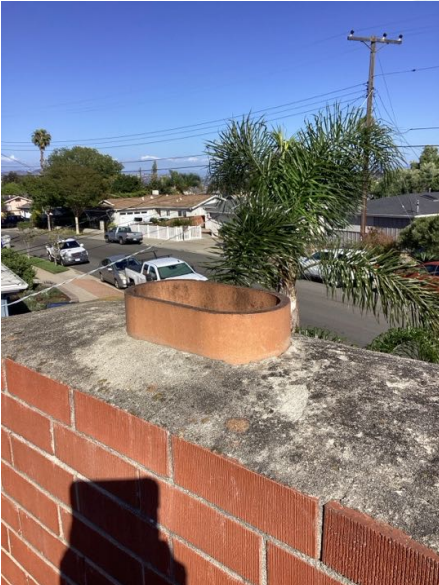
Missing Rain Cap

112: RAIN CAP: Rain cap missing; this will allow water entry. Recommend installing a rain cap by a chimney/fireplace specialist.

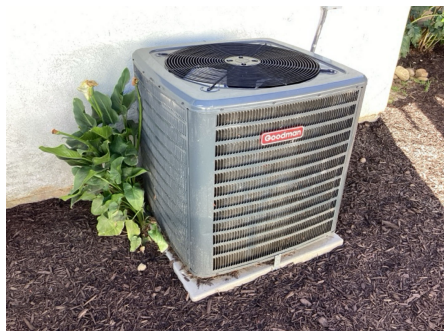
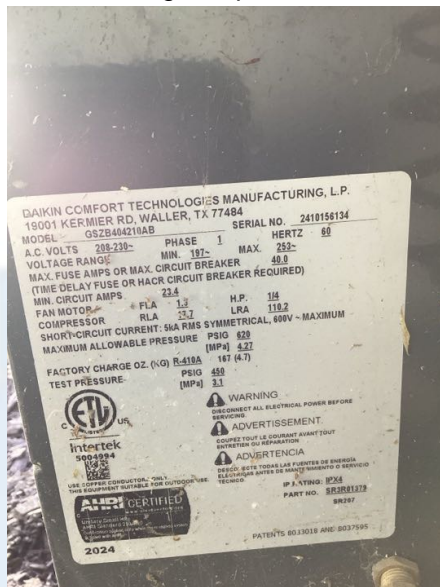
114: MANUFACTURER: The outside air conditioning compressor unit was manufactured by Goodman.

115: REFRIGERANT: Air conditioning system currently uses R410A refrigerant.

116: SIZE: Approximately "3.5 Tons."

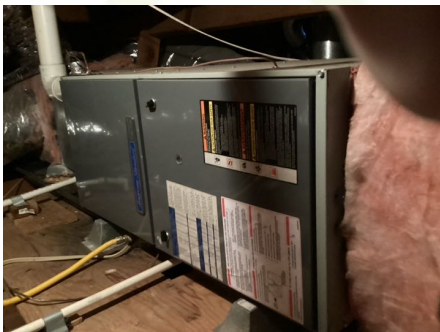
129: MANUFACTURER: Furnace is manufactured by American Standard.

130: WORKING SPACE: Furnace has the 30" x 30" minimum required working space in front of the furnace.

131: CONDITION: Furnace is functional.

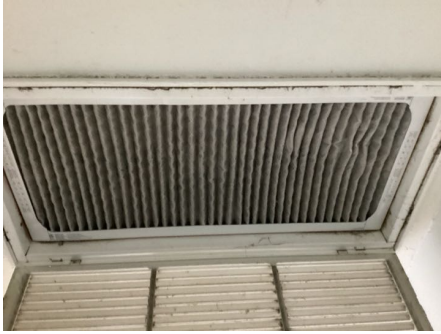
143: CONDITION: Filter is damaged. Filters clean the air before it passes through the blower, heat exchanger and evaporator coil. This helps to keep these components working efficiently. Filters also help clean the house air, making the environment more pleasant. Recommend installing a new filter.

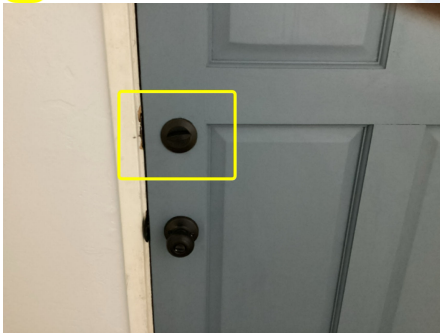
Hardware Sticks

148: Hardware needs adjustment. Recommend repair or replacement by a general contractor.

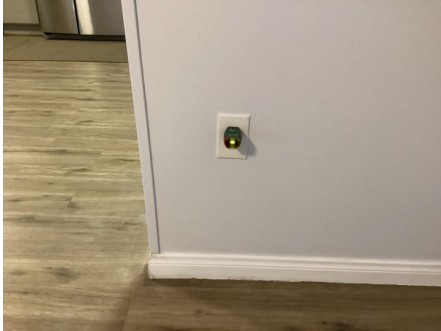
Example 1

150: Receptacle displays an open ground. This is a shock hazard. Recommend further evaluation by an electrical contractor.

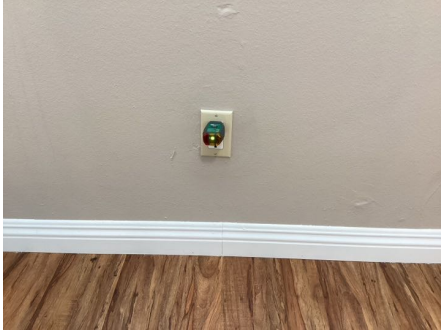
Example 1: Primary Bedroom

153: Receptacle displays an open ground. This is a shock hazard. Recommend further evaluation by an electrical contractor.

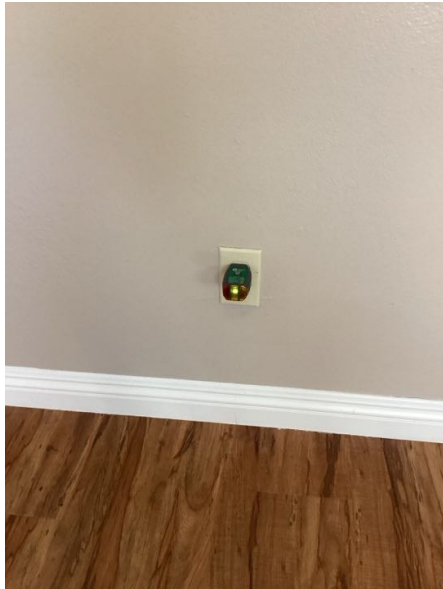
Example 1: Bedroom 2

155: Receptacle displays an open ground. This is a shock hazard. Recommend further evaluation by an electrical contractor.

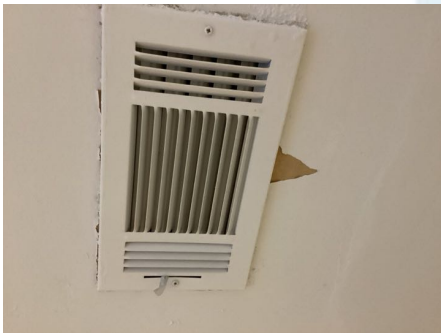
157: **CONDITION:** Ceiling damaged at connection. Recommend repair or replacement by a general contractor.

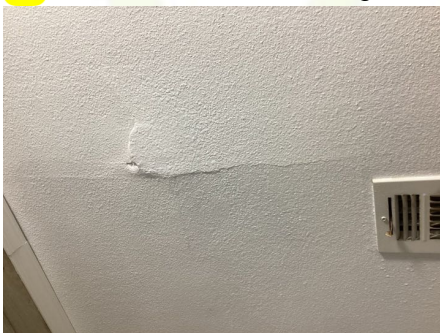
161: CONDITION: Ceiling damaged. Recommend repair or replacement by a licensed general contractor.

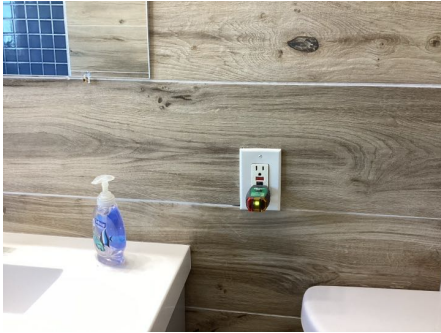
162: Receptacle displays an open ground. This is a shock hazard. Recommend correction by an electrical contractor.

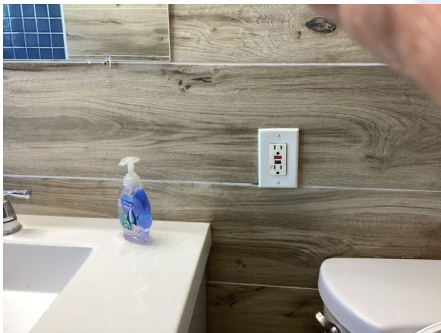
163: Faulty GFCI. This is a safety hazard. Recommend repair or replacement by an electrical contractor immediately.

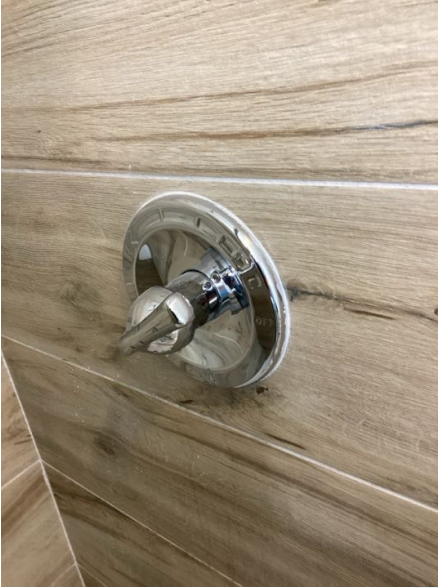
Primary Bathroom

165: FAUCETS: Hot and cold water supplies are reversed. This is not a functional problem but to someone who is not familiar with this condition unexpected hot water could scald them. I suggest contacting a plumbing contractor to correct.

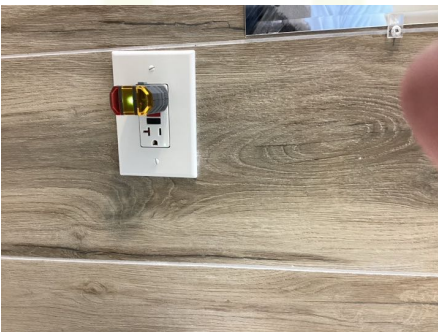
Primary Bathroom

168: Receptacle displays an open ground. This is a shock hazard. Recommend correction by an electrical contractor.

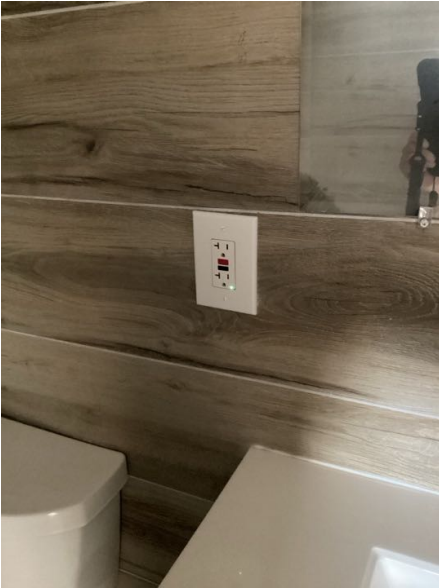
169: Ungrounded GFCI receptacle not marked as so. All ungrounded receptacles must be marked as ungrounded to let the user know there is no ground. This is a safety hazard. Recommend further evaluation / repair or replacement by an electrical contractor.

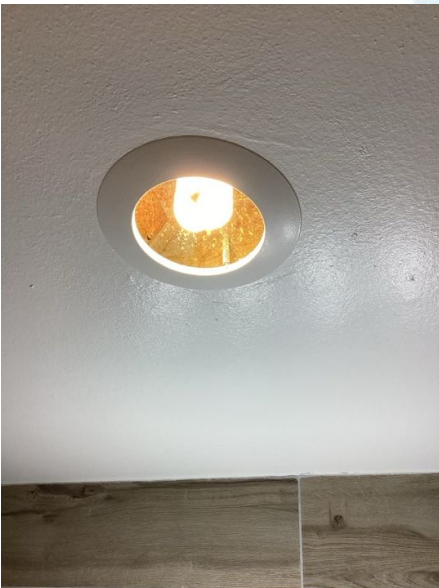
170: Light is an exposed bulb. Someone could bump this bulb with their head. This is a safety hazard. Recommend having an electrician replace with a proper protected lighting fixture.

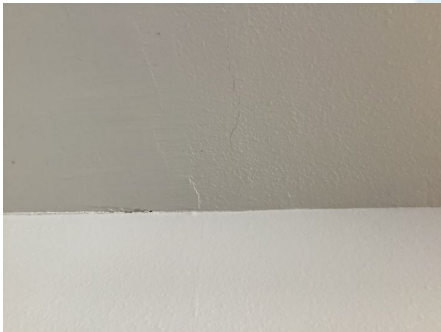
Example 1: Hallway

172: CONDITION: Small settlement cracks noted on the ceiling. If these cracks concerns you, I recommend contacting a general contractor for further evaluation and / or repairs.

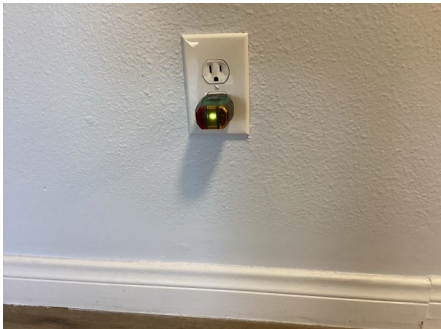
173: Receptacle displays an open ground. This is a shock hazard. Recommend further evaluation by an electrical contractor.

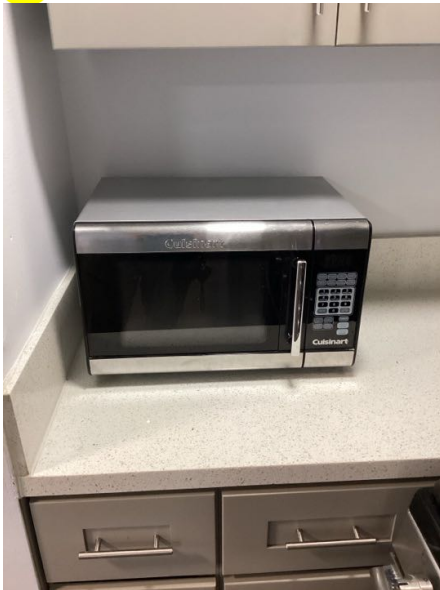
KITCHEN MICROWAVE

177: Did not test, installation is incomplete.

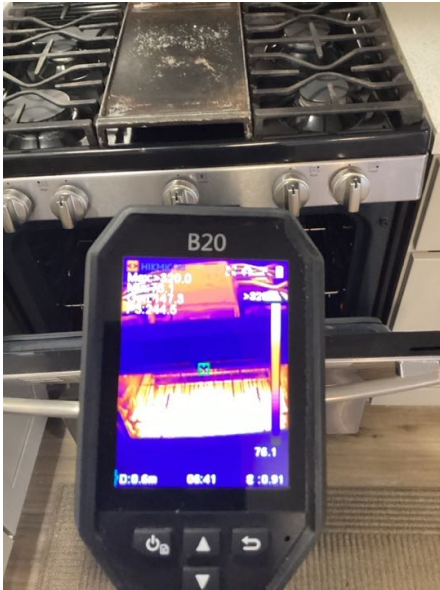
KITCHEN RANGE

178: Range is functional. The stovetop, oven, and gas valve are functional and the range is equipped with a required anti-tip device. Range was tested using normal operating controls and appeared to be serviceable.

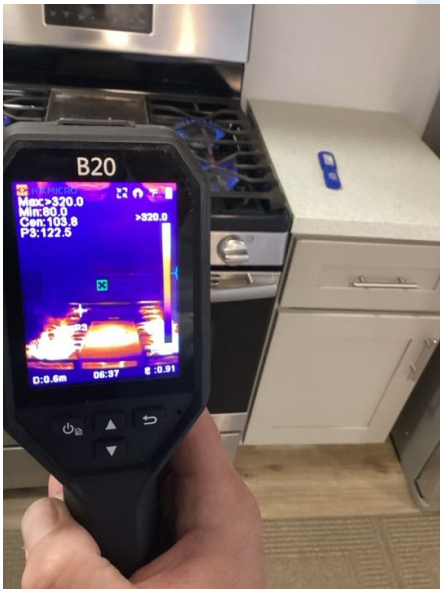
KITCHEN COOKTOP

179: TYPE: Gas cooktop present.

180: CONDITION: All burners operated properly when tested.

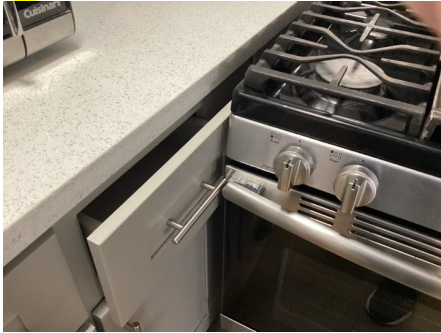
187: Door hits refrigerator. Recommend correction by a general contractor.

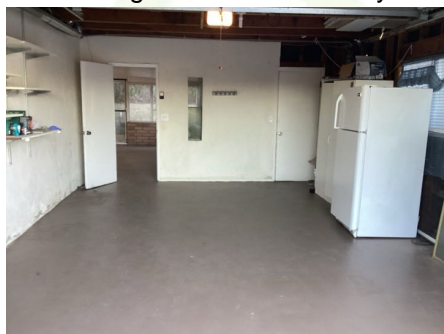
Garage Vehicle Door

212: CONDITION: Garage door is properly balanced and functional.
